CONNECTICUT RIVER BASIN  
BERLIN, CONNECTICUT

HALLMERE RESERVOIR DAM  
CT 00249

PHASE I INSPECTION REPORT  
NATIONAL DAM INSPECTION PROGRAM

JUNE 1979

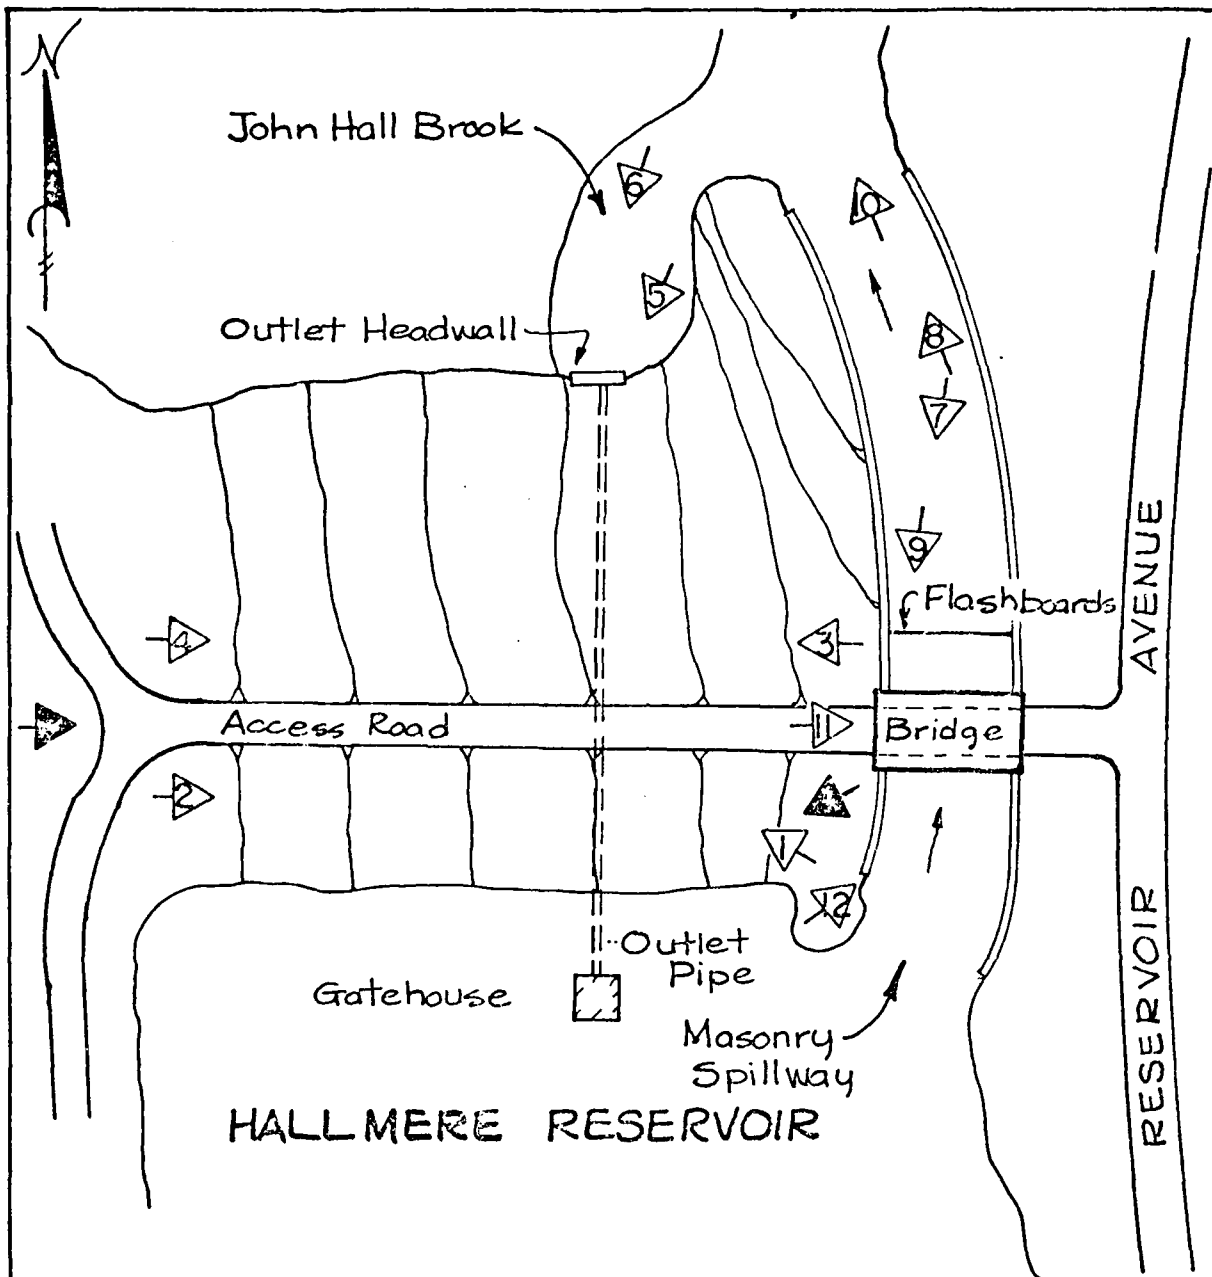
- Appendix  
"C" Photos
- Overview  
Photos

In the center of the dam, opposite the gatehouse, there appeared to be an unusual amount of voids in the upstream riprap that did not appear to be attributable entirely to the loss of fines. Remnants of the foundations for the gatehouse access bridge were present in the upstream face, together with one large stump about 3 ft. dia., and much small brush. (See Photo. No. 1 & No. 2, Appendix C).

The owner should implement the following maintenance measures: (1) remove brush and trees from the embankment; (2) restore riprap, backfill voids on the upstream face of the embankment, and control burrowing rodents; (3) clear spillway of growth and debris; (4) repair floor of the masonry wasteway; (5) reconstruct or remove the bridge over the spillway; (6) consider reconstruction of the access bridge to the control tower in order to facilitate the operations during periods of heavy rainfall; (7) develop a formal surveillance and flood warning system; and (8) institute procedures for an annual periodic technical inspection.
